**Exponent Report on PG&E Caribou-  
Palermo Asset Condition Investigation**

**November 1, 2019**

## **PG&E Caribou-Palermo Asset Condition Investigation**

Exponent  
149 Commonwealth Drive  
Menlo Park, CA 94025

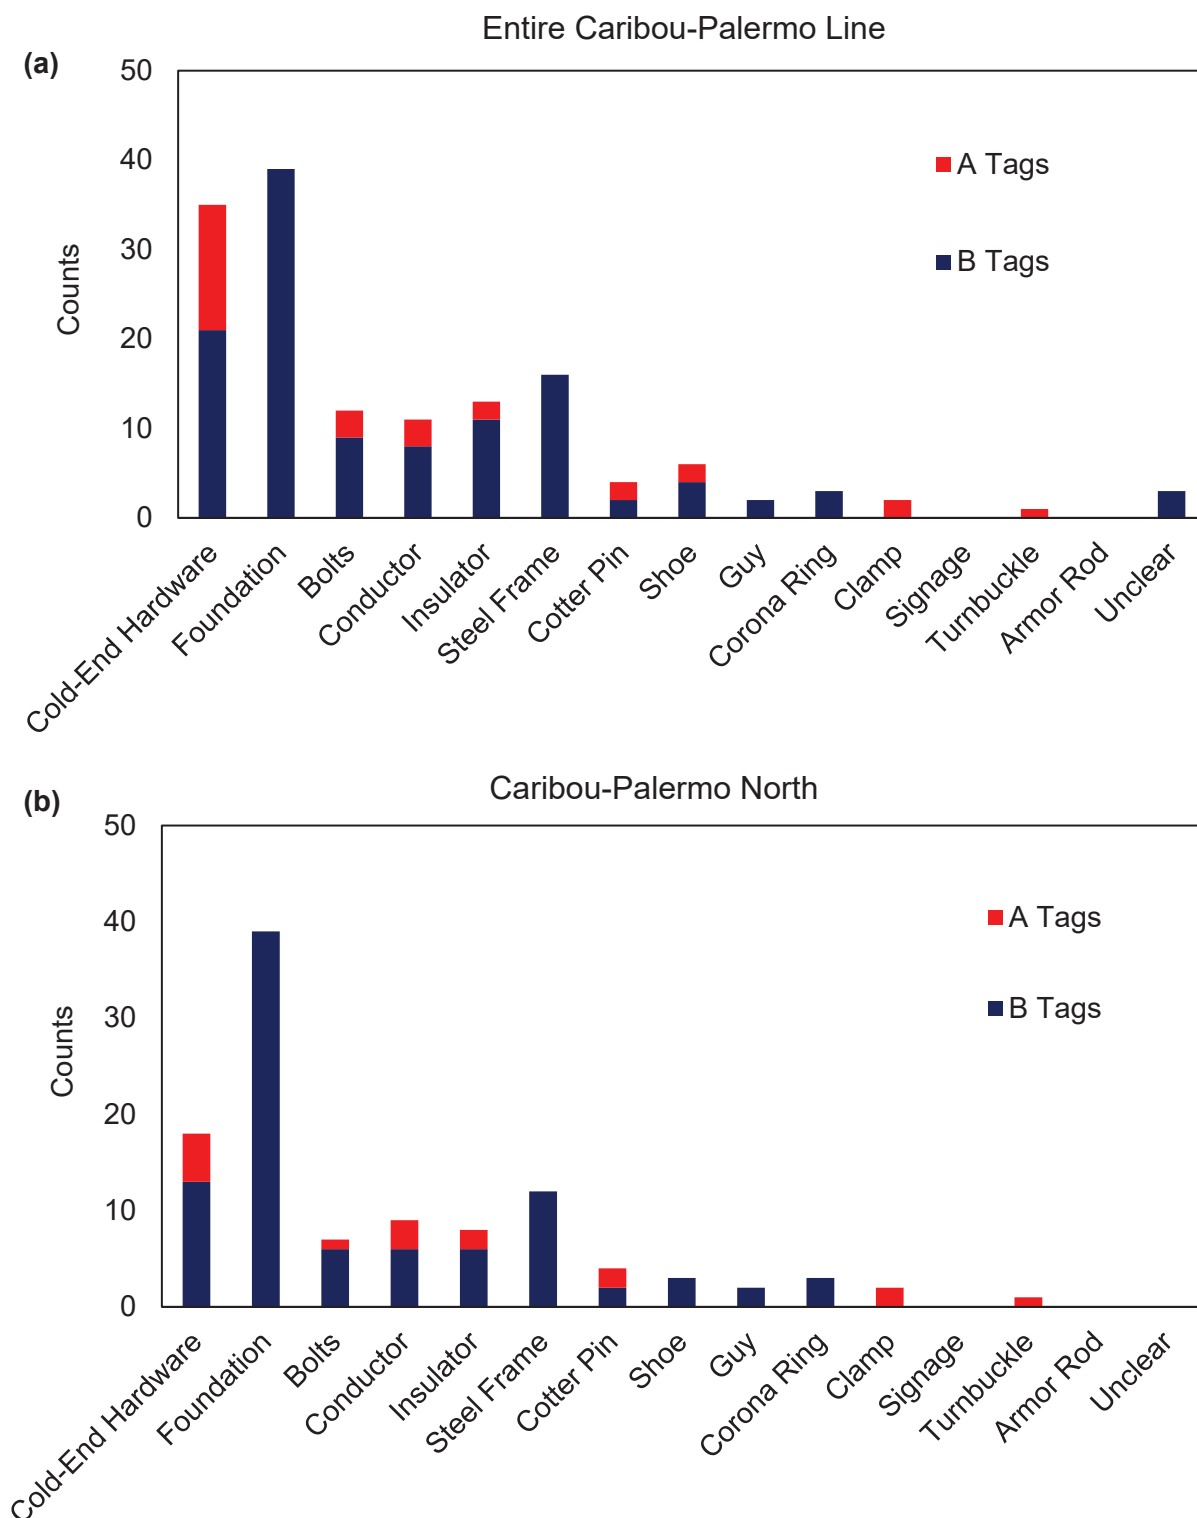
The number of post–Camp Fire Caribou-Palermo “A” and “B” tags associated with each of the 15 component type categories is shown in Figure 5(a). Cold-end hardware accounted for the highest number of “A” tags, as well as the second highest number of “B” tags. Tower foundations were associated with the highest number of “B” tags but no “A” tags. Notably, these two component types combined account for nearly four times the number of high-priority tags of the next most tagged component, and approximately half of all high-priority tags. In Figure 5(b), the distribution of component type categories is shown only for high-priority tags from steel lattice towers on Caribou-Palermo North.

Figure 5. Breakdown of post-Camp Fire high-priority (“A” and “B”) tags with respect to component type on (a) entire Caribou-Palermo line and (b) Caribou-Palermo North. (Tags are associated with single-circuit structures north of Tower 016/130.)

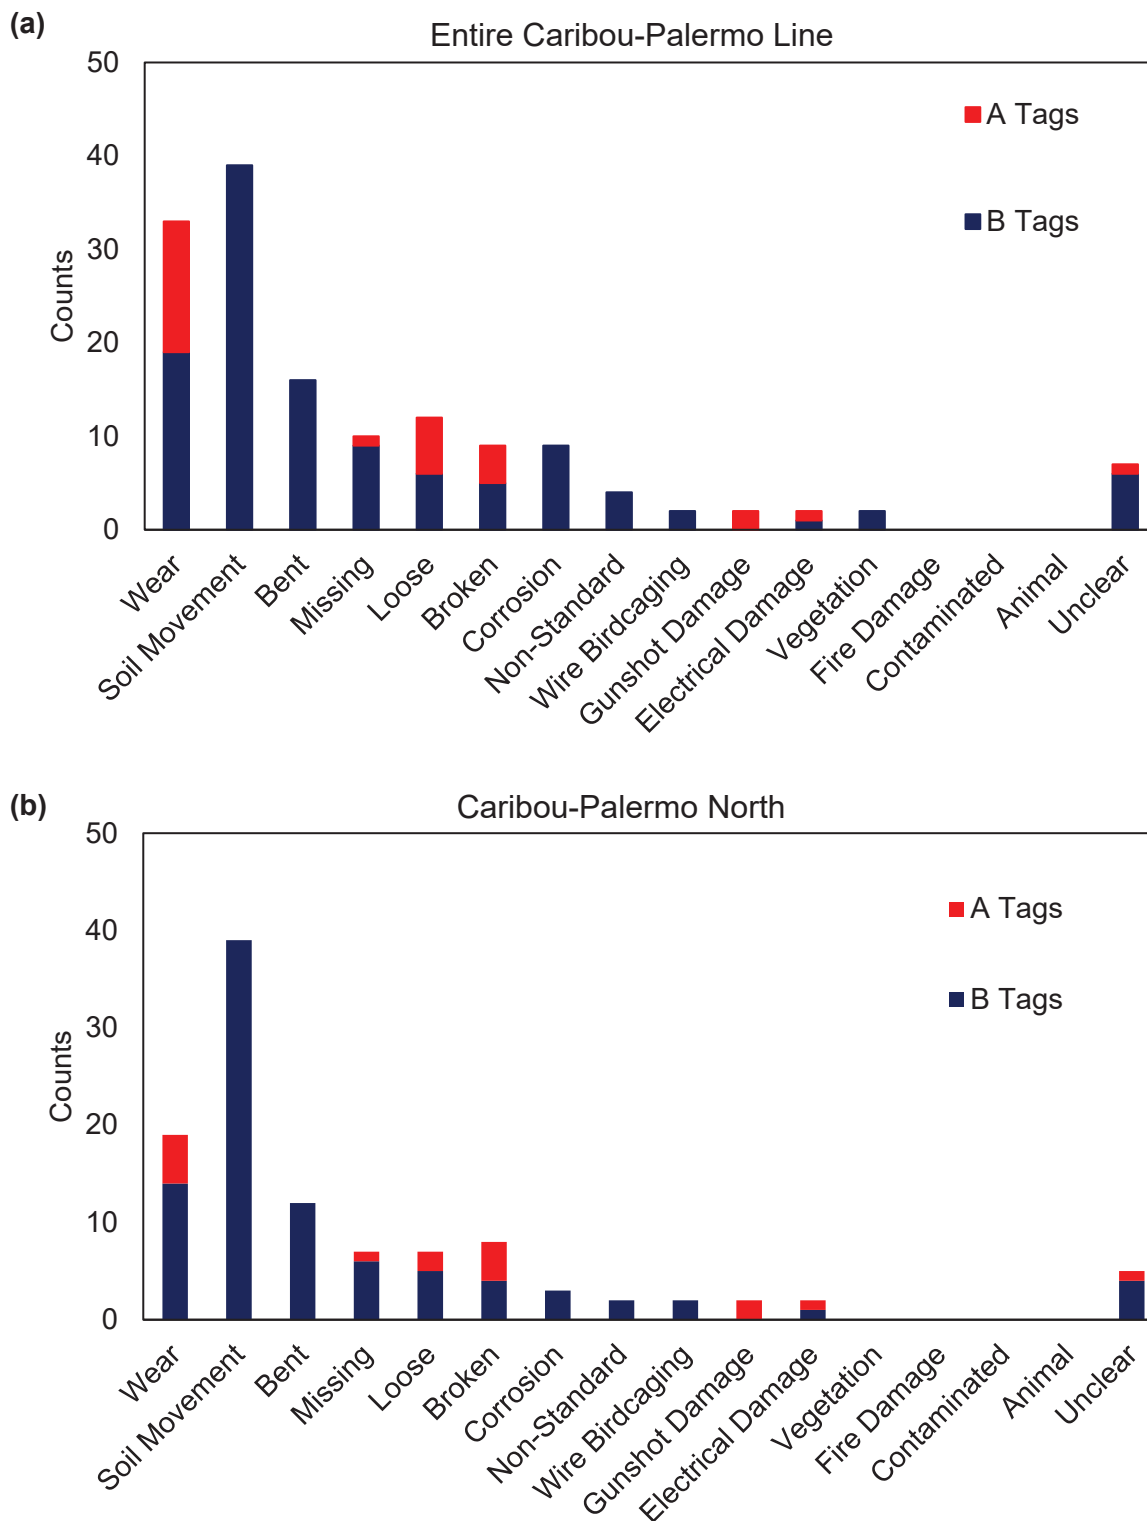
The number of “A” and “B” tags from Caribou-Palermo associated with each of the 16 damage mode categories is shown in Figure 6(a). The distribution of high-priority tags among damage mode categories closely parallels their distribution among component types. Wear tags are primarily associated with cold-end hardware, and soil movement is associated with foundations. These two damage modes represent the highest numbers of “A” and “B” tags, respectively, and, combined, account for more than four times the number of high-priority tags of any other damage mechanism. Tagged component breakdowns on Caribou-Palermo North are shown in Figure 6(b).

Figure 6. Breakdown of post-Camp Fire high-priority (“A” and “B”) tags with respect to damage mode on (a) entire Caribou-Palermo line and (b) Caribou-Palermo North. (Tags are associated with single-circuit structures north of tower 016/130.)

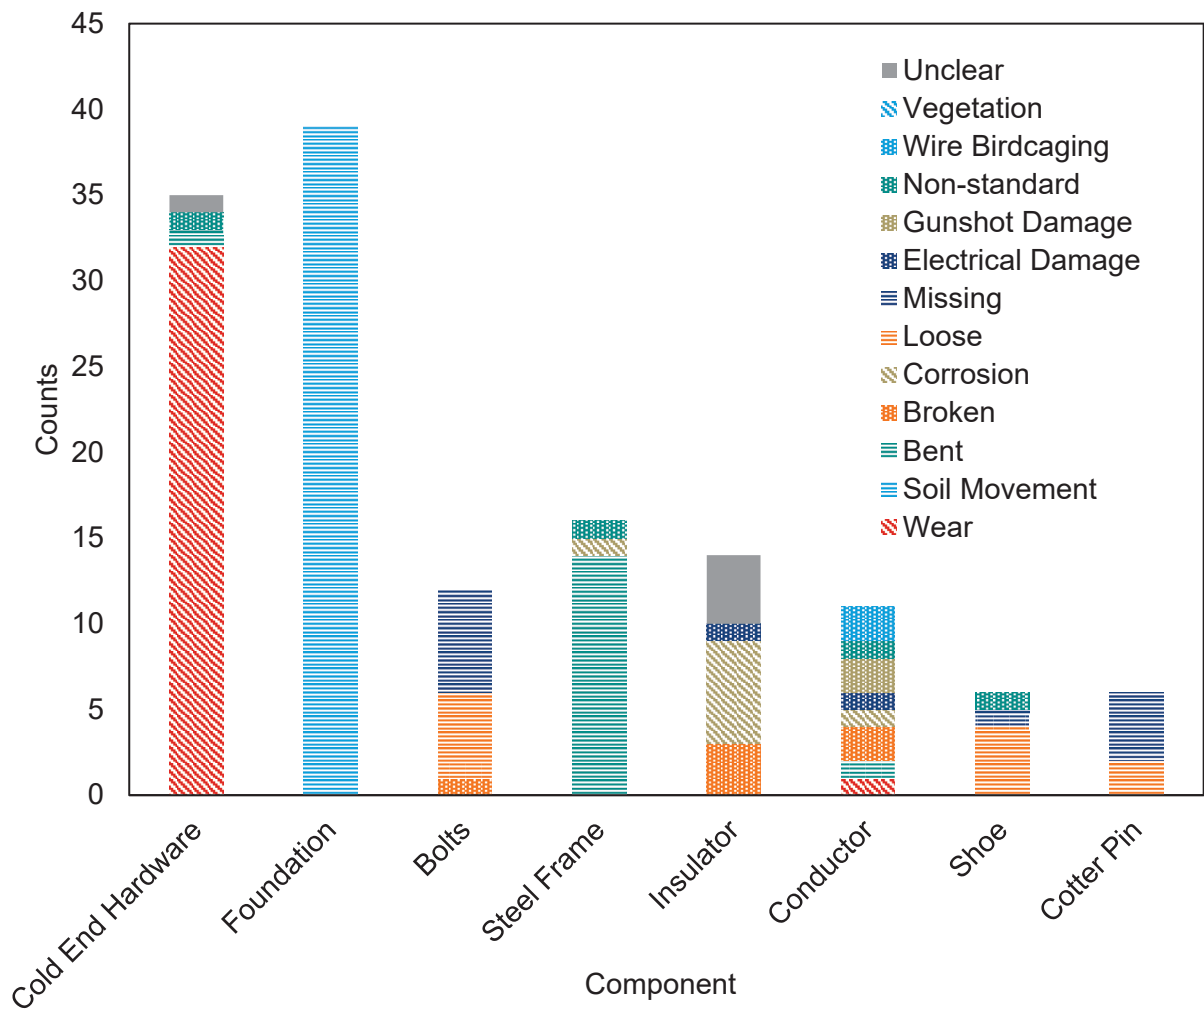
A breakdown of the damage modes associated with selected component types, Figure 7, indicates that cold-end hardware tags were almost exclusively associated with wear. Similarly, all foundation tags were associated with soil movement. We note that while soil movement may pose risk to the structural integrity of tower foundations, further inspection is required to assess whether soil movement actually resulted in damage to any components. A closer examination of both cold-end hardware / wear tags and foundation/soil movement tags is provided in the following section.

Figure 7. Breakdown of post-Camp Fire Caribou-Palermo high-priority tags by component type and damage mode.

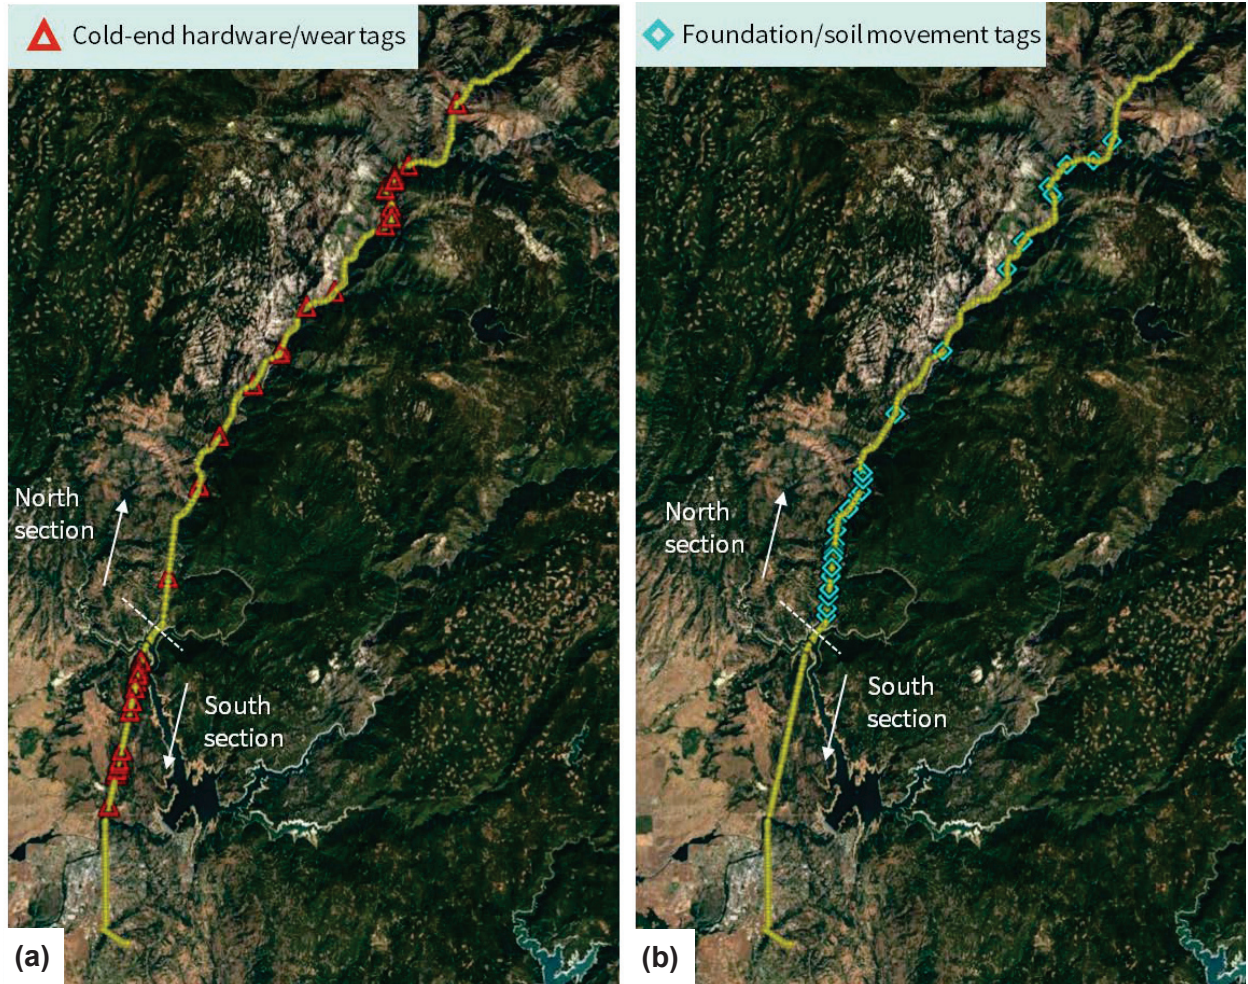
No apparent correlation was found between cold-end hardware and foundation tags. The locations of high-priority tags associated with cold-end hardware / wear or foundation/soil movement are mapped in Figure 10. The majority of the foundation/soil movement tags were clustered just north of Lake Oroville. Cold-end hardware / wear tags were distributed along the length of Caribou-Palermo, both north and south of Lake Oroville.

Figure 10. Maps of post-Camp Fire high-priority (a) cold-end hardware / wear tags and (b) foundation/soil movement tags on Caribou-Palermo.

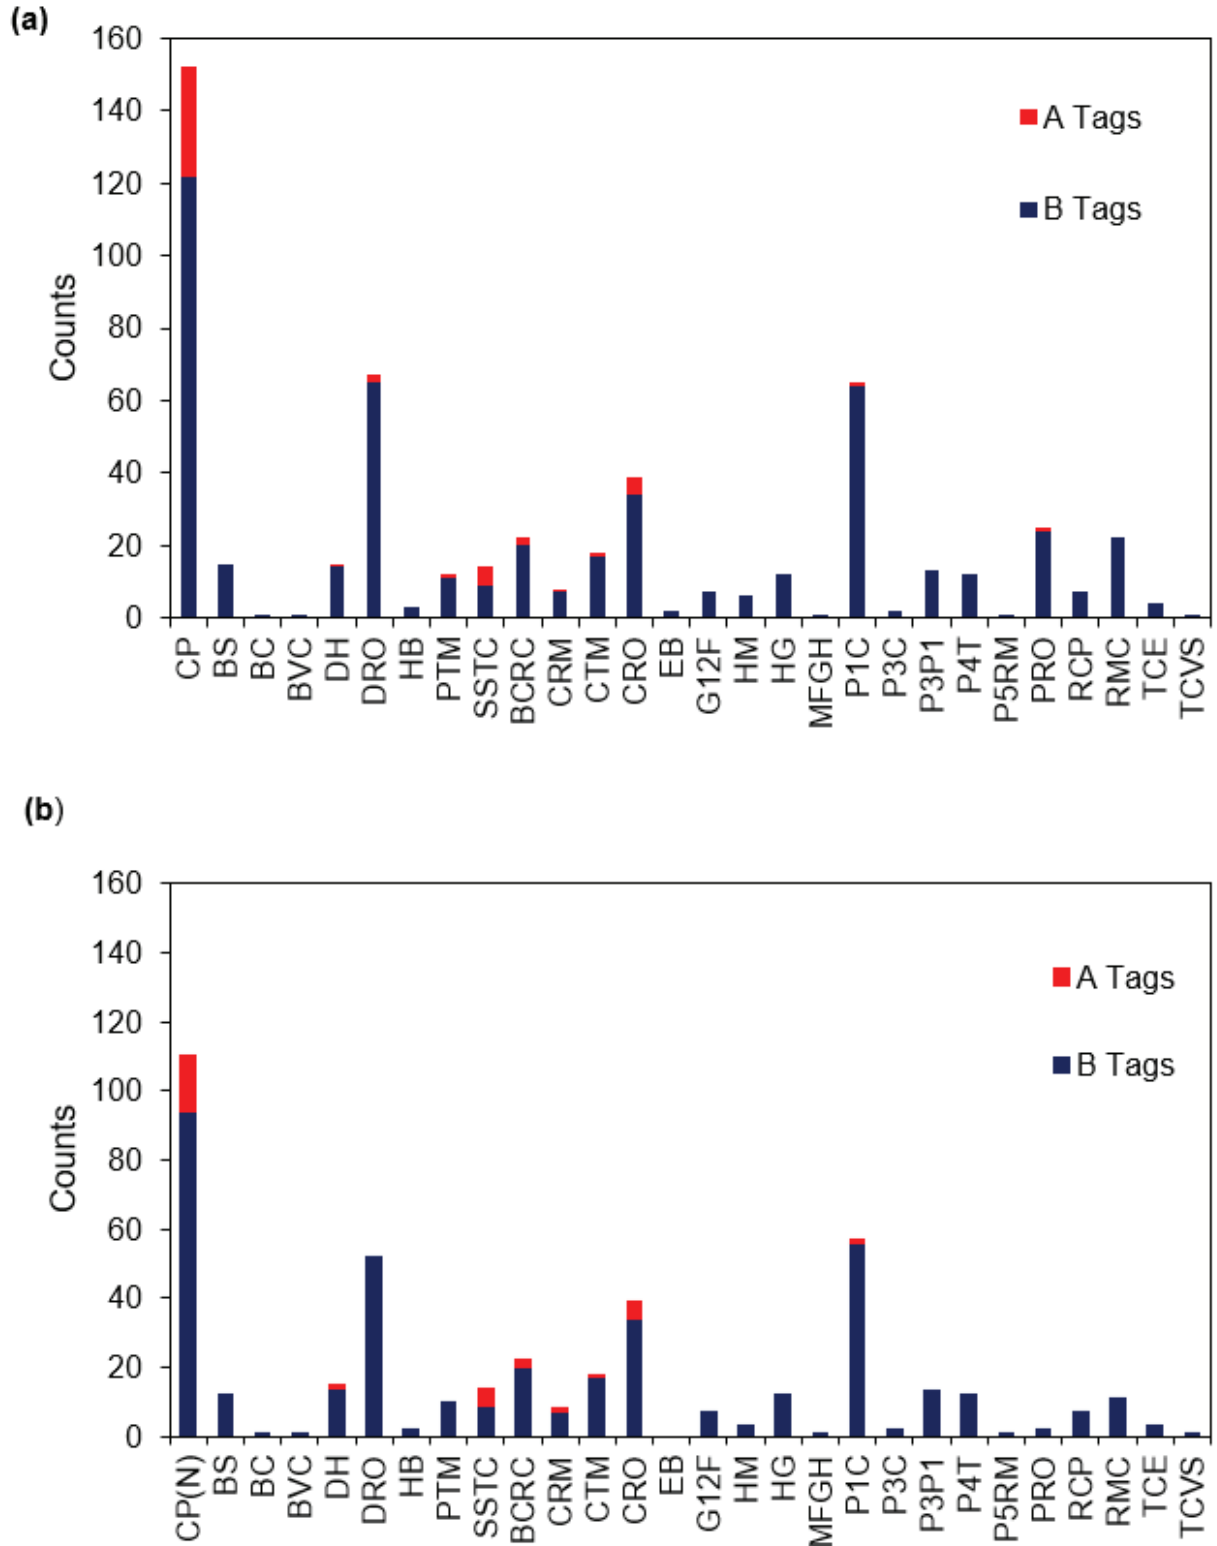
Figure 11(a) compares the overall high-priority tag count between Caribou-Palermo and the comparison lines. The Caribou-Palermo line had substantially more high-priority tags than any other comparison line; however, Caribou-Palermo also contained an above-average number of steel lattice towers, and steel lattice towers over 1,000 feet. The overall number of steel lattice towers and steel lattice towers over 1,000 feet (obtained from Google Earth) are shown in Figure 12. The normalized tag count at each priority level for Caribou-Palermo and the other comparison lines is shown in Figure 13.

Figure 11. Total post-Camp Fire tag count for Caribou-Palermo and comparison lines on (a) all steel lattice towers, and (b) all steel lattice towers above 1,000 feet.

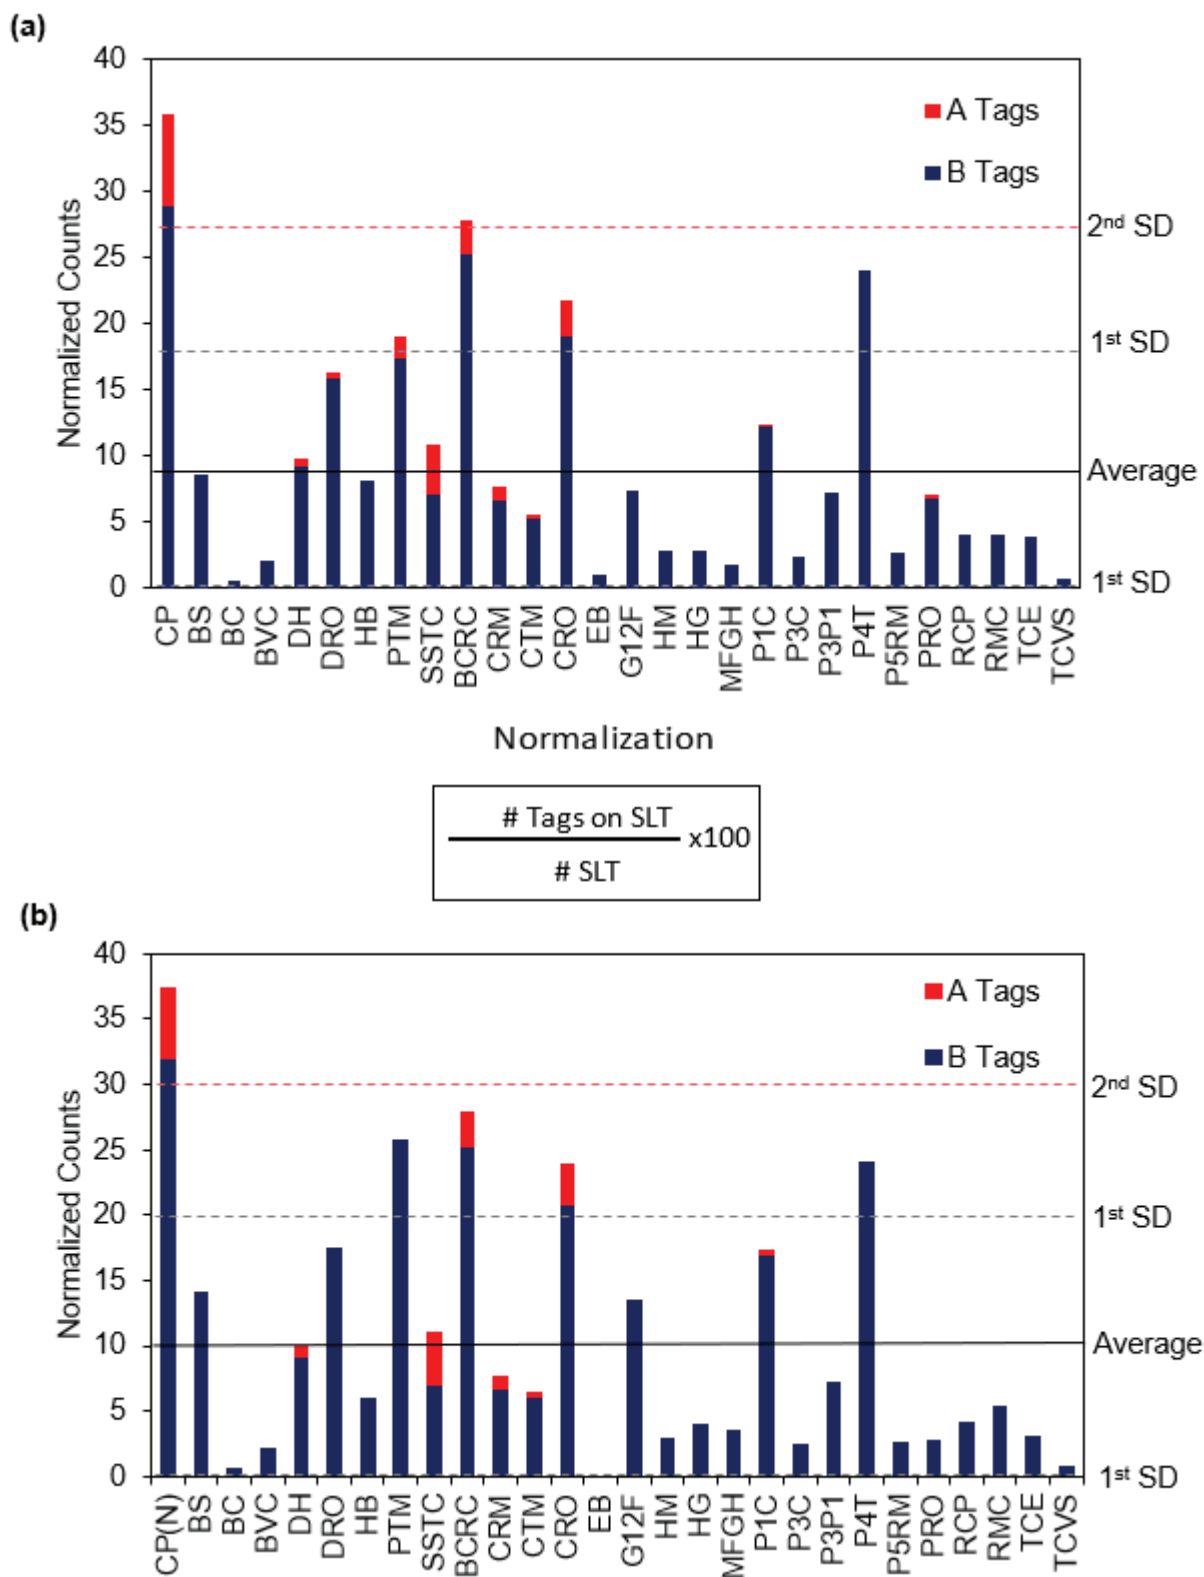
The Caribou-Palermo line exhibited a higher normalized high-priority (“A” + “B”) post-Camp Fire tag count than all other comparison lines, as shown in Figure 13. Furthermore, three of the four lines with the next highest normalized tag counts are located adjacent to Caribou-Palermo in (or near) the North Fork Feather River Canyon: Bucks Creek–Rock Creek–Cresta (BCRC), Paradise–Table Mountain (PTM), and Cresta–Rio Oso (CRO).

Figure 13. Normalized post-Camp Fire tag rate for Caribou-Palermo North (CP(N)) and comparison lines considering (a) steel lattice towers, and (b) steel lattice towers above 1,000 feet. SLT is steel lattice tower, SD is standard deviation.

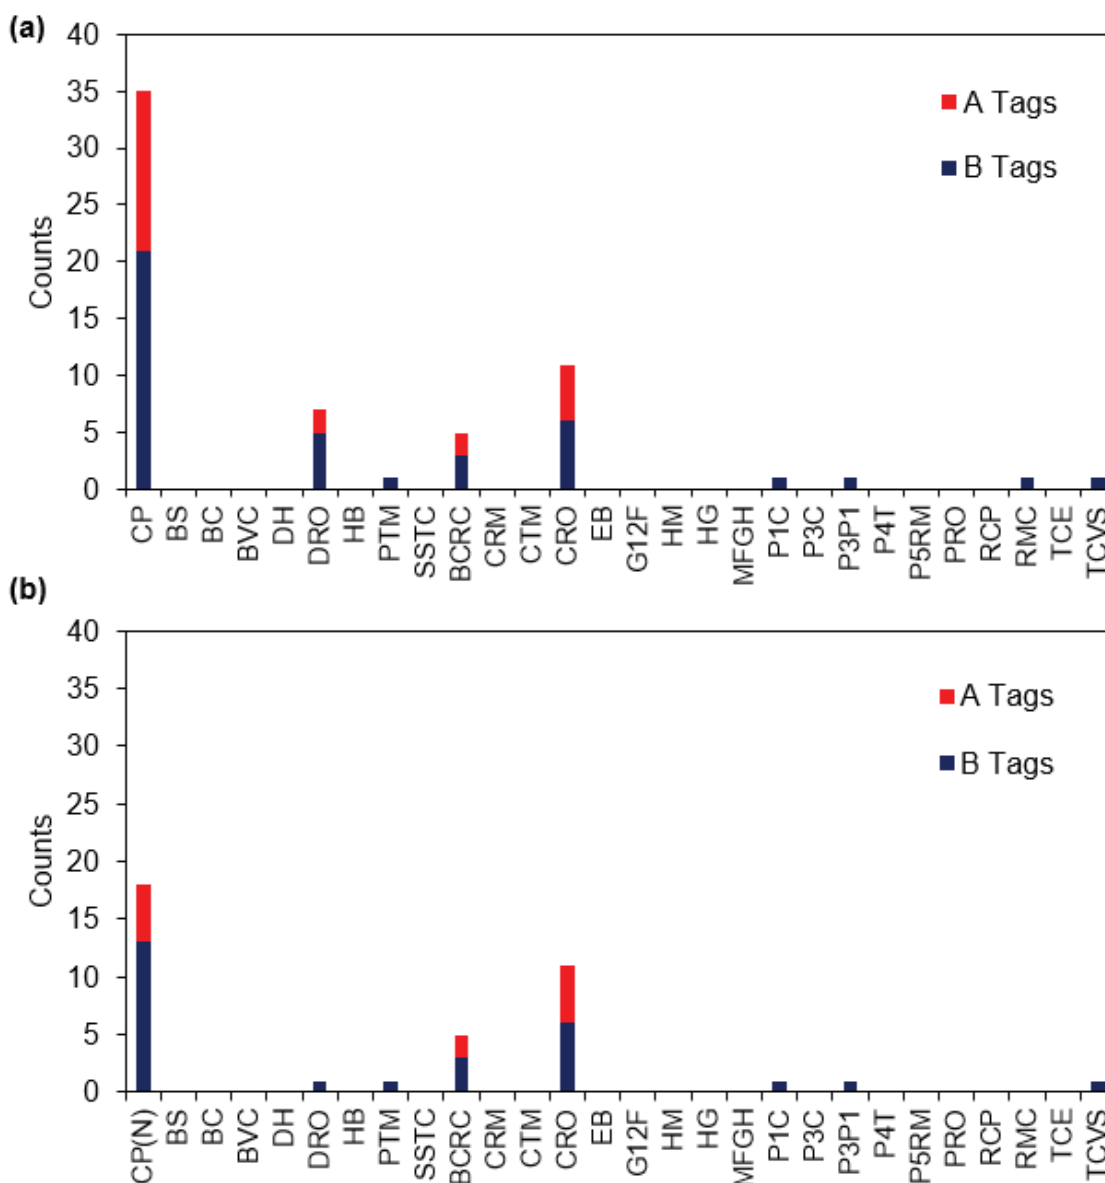
Figure 14 shows the counts of post-Camp Fire “A” and “B” tags associated with cold-end hardware on all comparison lines. The absolute count of cold-end hardware tags on Caribou-Palermo greatly exceeds that of any other comparison line; however, after normalizing by the number of steel lattice structures in each line, two other lines, Bucks Creek–Rock Creek–Cresta (BCRC) and Cresta–Rio Oso (CRO), are found to have comparable normalized counts of cold-end hardware tags, shown in Figure 15. These three lines, all located in the North Fork Feather River Canyon, exhibit significantly more post-Camp Fire cold-end hardware / wear tags than any of the other comparison lines. Examples of cold-end hardware / wear are shown in Figure 8.

Figure 14. Total counts of post-Camp Fire cold-end hardware tags for Caribou-Palermo (CP) and comparison lines for (a) steel lattice towers and (b) steel lattice towers over 1,000 feet of elevation.

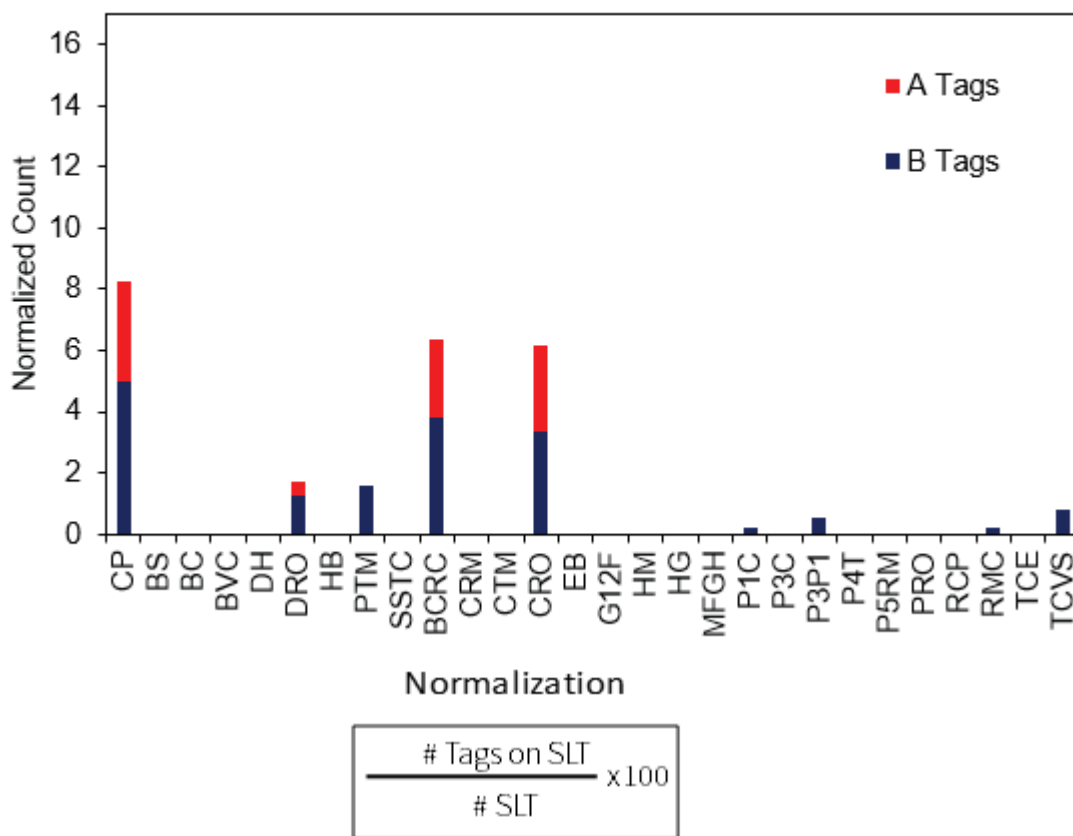
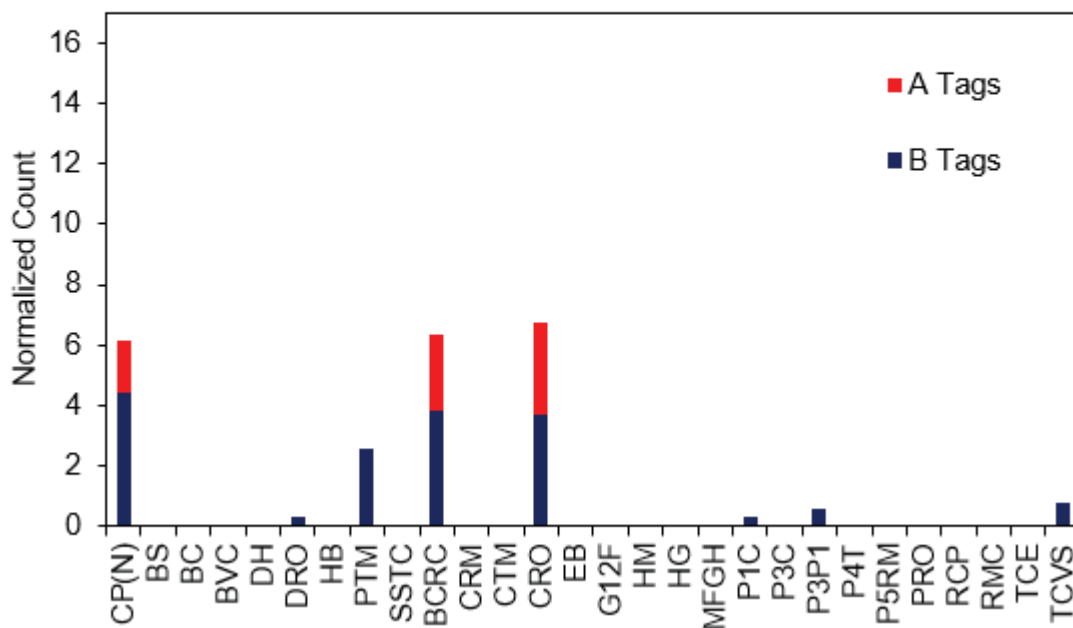
Figure 15. Normalized post-Camp Fire cold-end hardware tag counts for Caribou-Palermo (CP) and comparison lines for (a) steel lattice towers and (b) steel lattice towers over 1,000 feet of elevation. SLT is steel lattice tower.

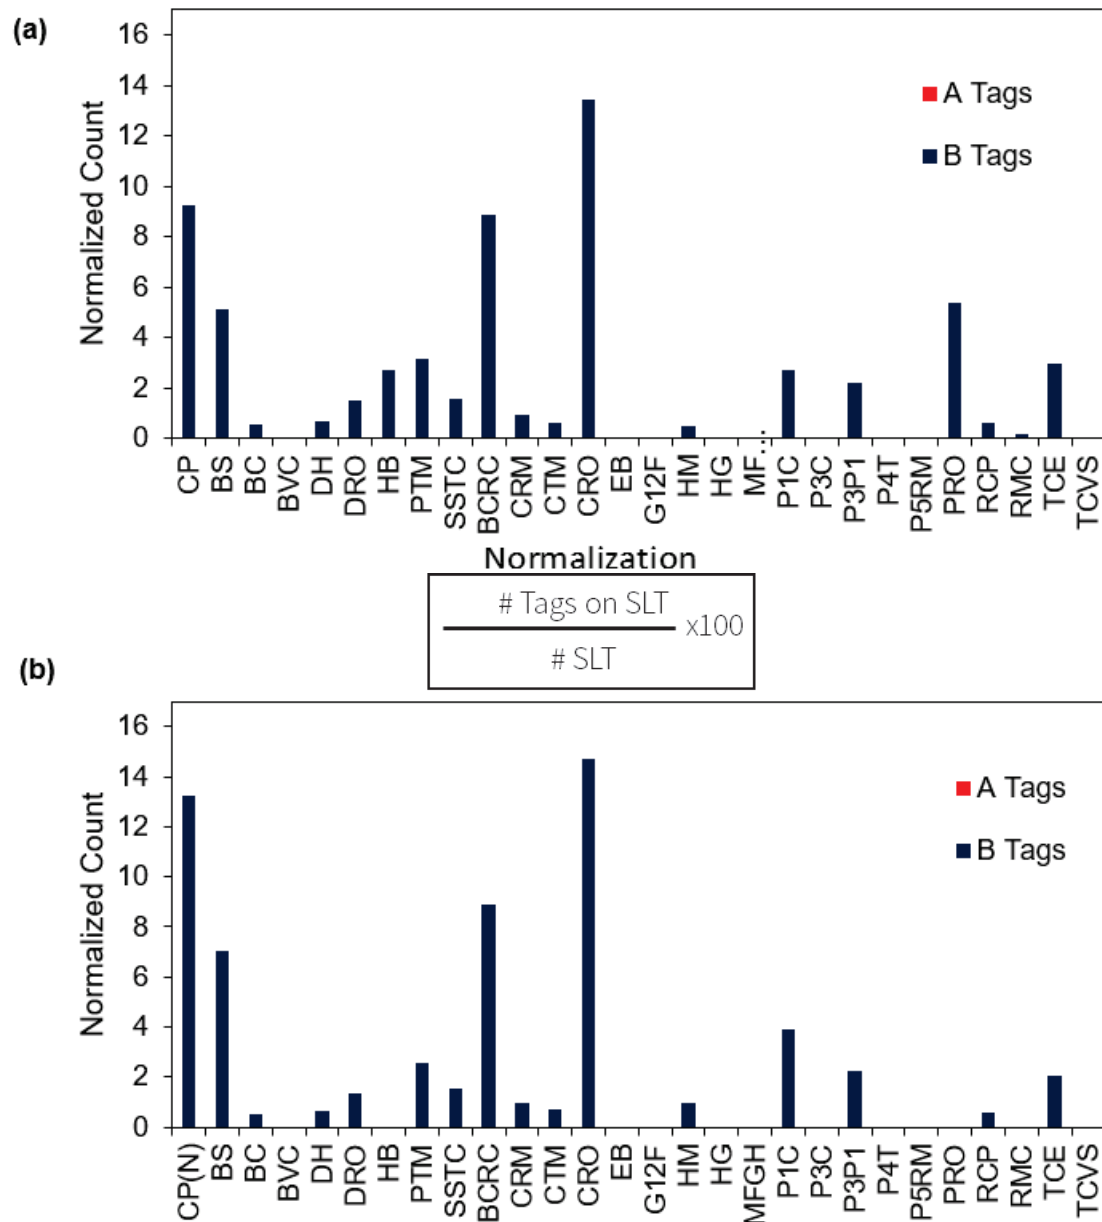
The most common Caribou-Palermo high-priority “B” tag was associated with buried foundations. Although Caribou-Palermo had roughly twice the number of buried foundation tags as the next highest comparison line, when normalized for the number of steel lattice towers Caribou-Palermo had a comparable number of foundation tags to other lines in the North Fork Feather River Canyon such as Bucks Creek–Rock Creek–Cresta (BCRC) and Cresta–Rio Oso (CRO), as shown in Figure 16.

Figure 16. Normalized count of tags associated with foundation tags for Caribou-Palermo (CP) comparison lines for (a) steel lattice towers and (b) steel lattice towers over 1,000 feet of elevation. SLT is steel lattice tower, SD is standard deviation.

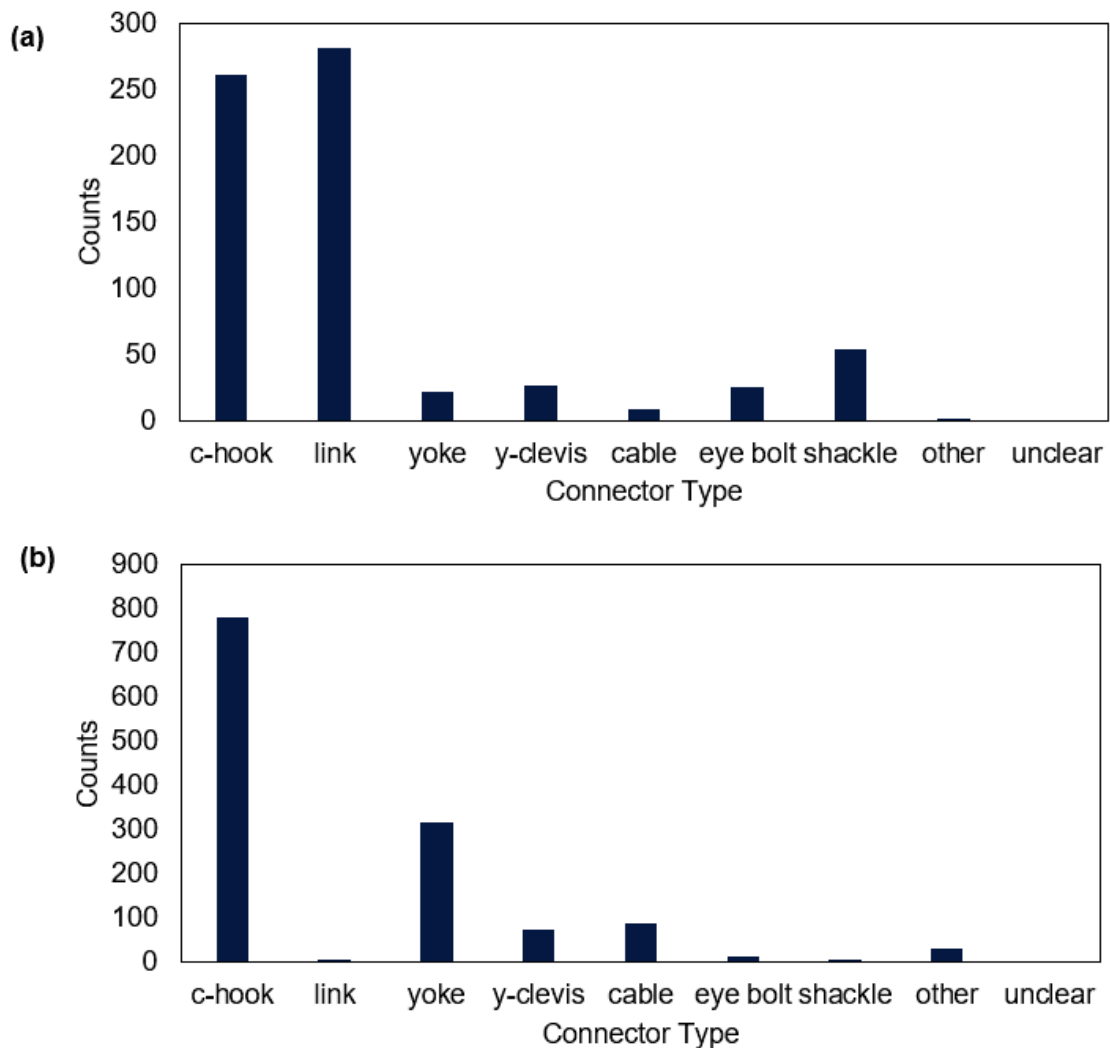
Available drone photos were used to determine the type of cold-end insulator hardware on each Caribou-Palermo tower, as well as selected available comparison lines as described in the methodology section. More than 4,000 insulator attachment points were categorized on Caribou-Palermo, CRO, DH, DRO, PTM, and BCRC lines. The numbers of each connection type on Caribou-Palermo South and on Caribou-Palermo North are shown in Figure 17. This analysis shows that the link style connection was unique to Caribou-Palermo South and was not found on Caribou-Palermo North or any of the comparison lines. Example link connections are shown in Figure 18.

Figure 17. Counts of insulator connection types present on (a) Caribou-Palermo South and (b) Caribou-Palermo North.

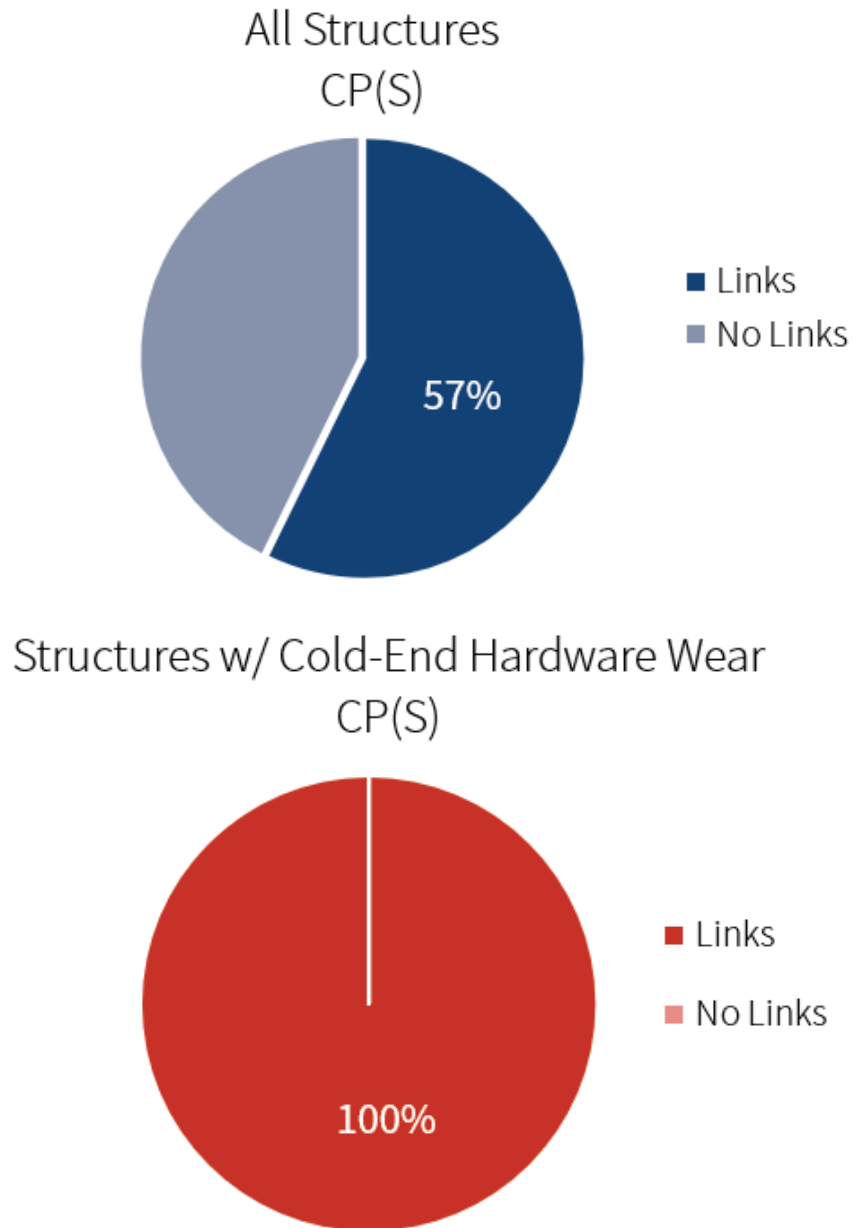
Approximately half of the Caribou-Palermo South steel lattice towers contained link connections. However, all of the high-priority Caribou-Palermo South cold-end hardware / wear tags were on structures with link connections (Figure 19). For cases in which a tagged structure contained multiple connection types, the link connection was determined to be the connection likely associated with the wear tag, based on inspector text and photographs of each connection.

Figure 19. Of the post-Camp Fire drone-inspected steel lattice towers on Caribou-Palermo South, approximately 57 percent contained one or more link connections. However, all 14 of the high-priority cold-end hardware / wear tags on Caribou-Palermo South were on structures with link connections.

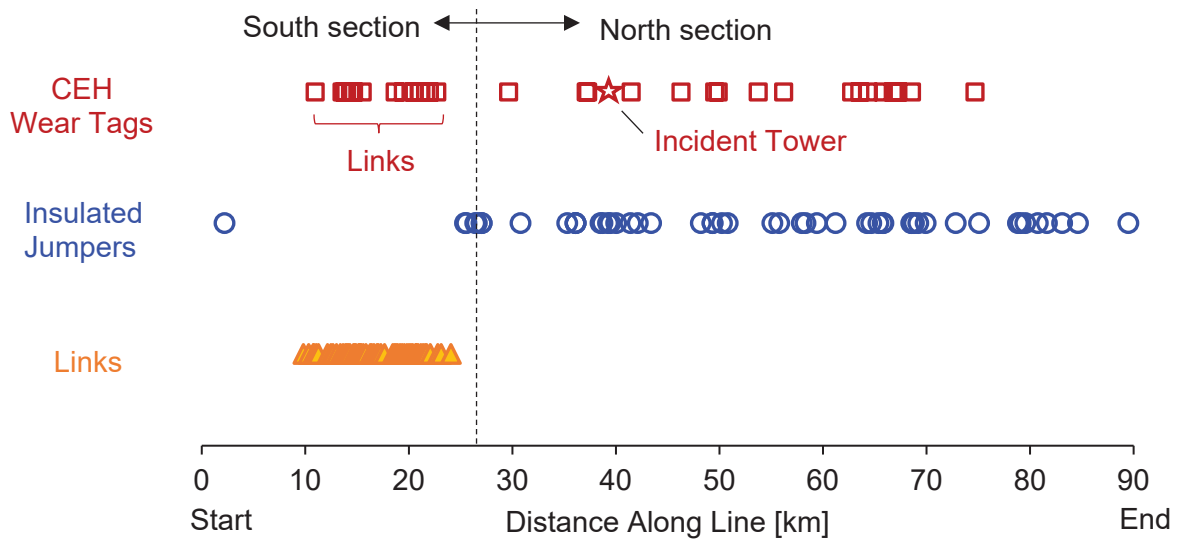
across a smaller area could increase the link wear rate, and may contribute to the higher incidence of cold-end hardware / wear tags associated with links compared to C-hooks on Caribou-Palermo South. A plot of the link connection locations along the length of Caribou-Palermo is shown in Figure 21.

Figure 21. High-priority cold-end hardware / wear tags mapped in conjunction with link connectors and insulated jumpers on Caribou-Palermo.

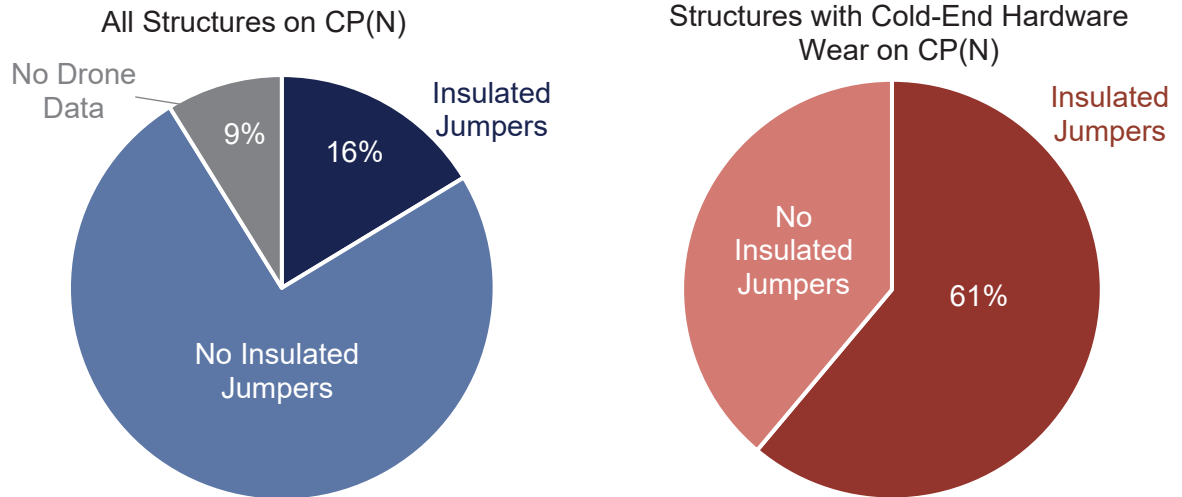
Using the post-Camp Fire drone inspection data, the hot end (conductor end) of each insulator-to-tower attachment point was characterized as attaching to either the main line or a jumper. Insulators connected to jumpers on Caribou-Palermo were found primarily on Caribou-Palermo North, as shown in Figure 21. Roughly one-sixth of Caribou-Palermo North structures contained insulated jumpers. However, more than 60 percent of the high-priority cold-end hardware / wear tags on Caribou-Palermo North were associated with structures that contained insulated jumpers, as shown in Figure 23.

Figure 23. Pie charts showing the percentage of post-Camp Fire structures with insulated jumpers on Caribou-Palermo North (left), compared to the number of structures with insulated jumpers with cold-end hardware / wear tags (right).

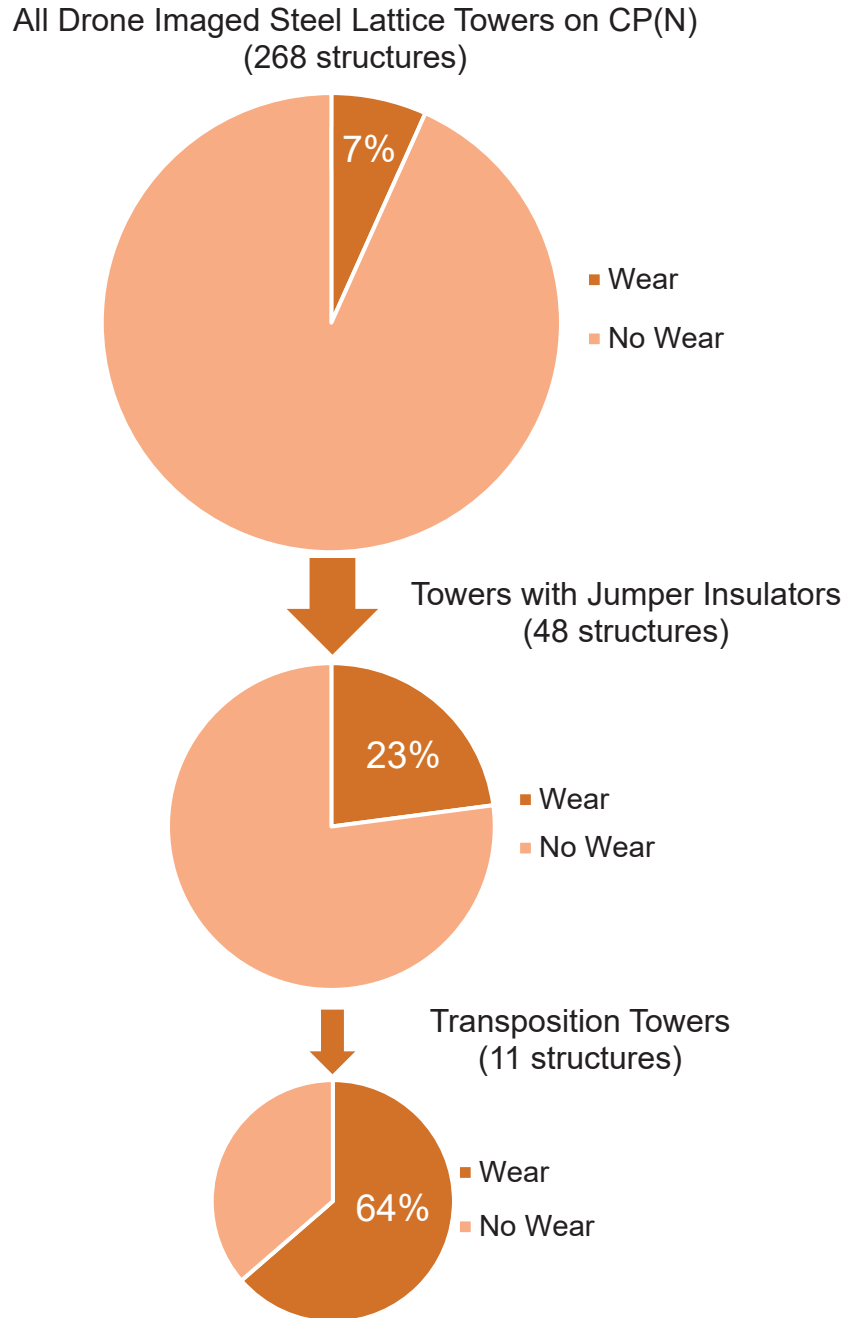
Suspended insulators attached to the jumpers are likely not subjected to Aeolian vibration conditions traditionally associated with tensioned conductors. Rather, insulated jumper connector wear is likely the result of greater freedom of movement between the conductor/insulator couple and the tower, specifically due to the low jumper line tension. A breakdown of Caribou-Palermo North structures with cold-end hardware / wear tags is given in Figure 24.

Figure 24. Breakdown of Caribou-Palermo North cold-end hardware / wear tag rates for all steel lattice towers, all steel lattice towers with jumper insulators, and all transposition towers. All transposition towers on Caribou-Palermo North contain jumpers attached to insulators.

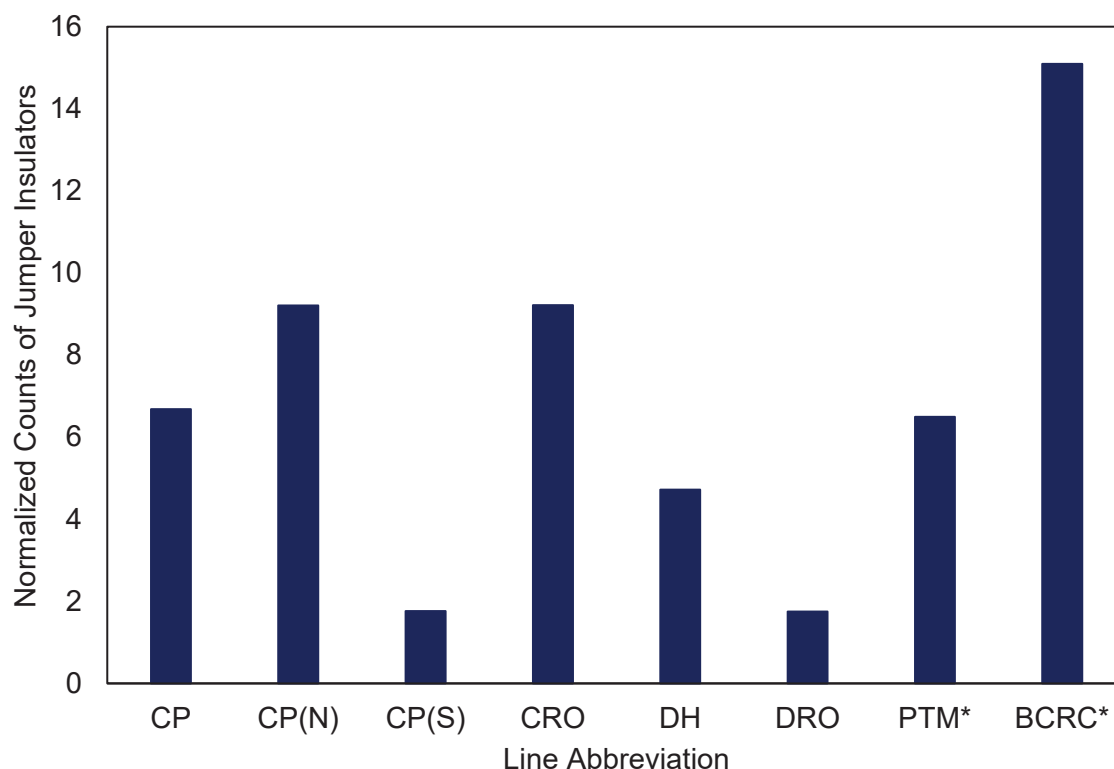
Normalized counts of insulators attached to jumpers for the Caribou-Palermo, Cresta–Rio Oso (CRO), Drum-Higgins (DH), Drum–Rio Oso (DRO), Paradise–Table Mountain (PTM), and Bucks Creek–Rock Creek–Cresta (BCRC) lines are shown in Figure 25, as determined from post–Camp Fire drone inspection data. We note that normalized counts for PTM and BCRC were determined from a relatively small number of steel lattice towers, based on the available drone inspection photos at the time of analysis. CRO and BCRC, which exhibited high normalized counts of cold-end hardware / wear, comparable to Caribou-Palermo (Figure 15), also have high normalized counts of insulated jumpers. Of the 16 high-priority cold-end hardware / wear tags on BCRC and CRO, nine (56%) were associated with insulators attached to jumpers.

Figure 25. Normalized counts of insulated jumpers on Caribou-Palermo (CP) and selected comparison lines. Counts of insulators attached to jumpers were normalized by the total number of drone-inspected insulator-tower attachment points as of May 13, 2019, and multiplied by 100. (\* Fewer than 21 drone-inspected steel lattice towers as of May 13, 2019.)
